BUILDING CONDITION ASSESSMENT
BERLIN FALLS PARK
BERLIN, MARYLAND

Prepared For:
The Town of Berlin
10 William Street
Berlin, Maryland 21811

Prepared By:
Davis, Bowen & Friedel, Inc.
601 East Main Street, Suite 100
Salisbury, Maryland 21804

June 16, 2017

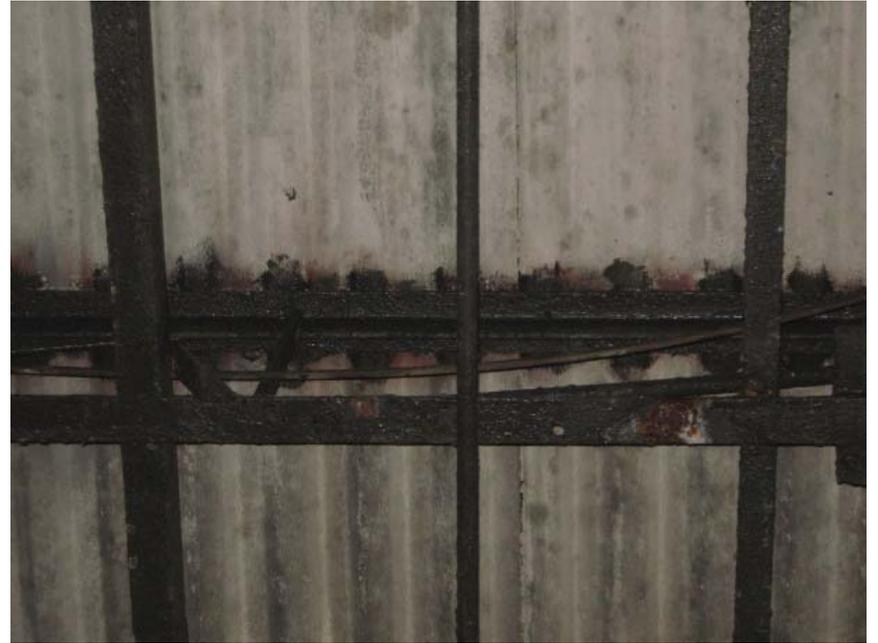
Photo 11

6. Some open web joist diagonals have been damaged. Refer to Photo 9.
7. The bottom chord of at least one joist broken. Refer to Photo 10.
8. The bottom chords of many joists have been altered by drilling and welding. Refer to Photo 11.

1. Numerous areas of the steel roof decking should be replaced or completely replaced.
2. All open web steel roof joists should be replaced and or reinforced.
3. Numerous steel beams will need to be reinforced.
4. The steel columns should be sand-blasted cleaned and repaired/reinforced.
5. Headers should be installed in exterior wall openings. Corroded exterior wall headers should be cleaned painted and sealed.
6. Interior wall opening header should be repaired and one replaced.

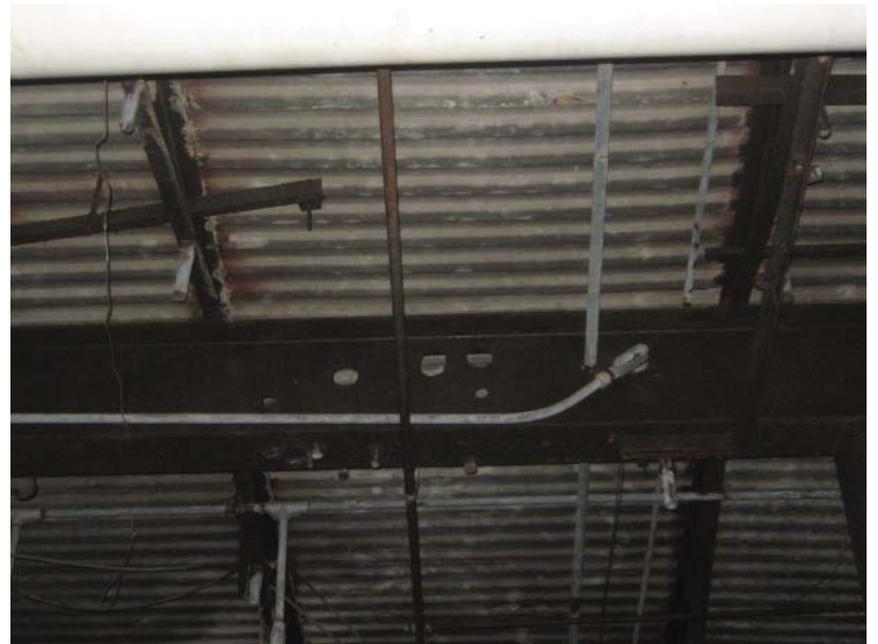
Photo 12

9. The joists are therefore in generally poor to failed condition.
10. Holes have been cut into the webs of some steel beams. Refer to Photo 12.
11. The steel columns are in fair to poor condition. Portions of the columns exhibit significant corrosion, severe pitting, impact damage and delamination. Refer to Photos 13 through 16.

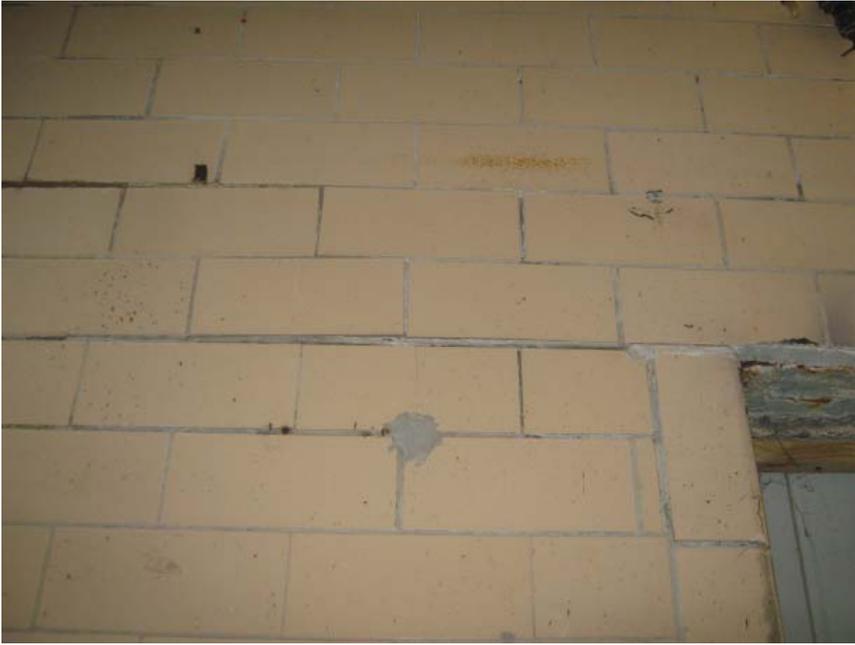
Photo 21

12. Openings have been cut in the exterior concrete masonry wall without headers. Refer to Photos 17 through 20.
13. Steel headers in the exterior wall have been affected by corrosion, swelled and cause some vertical displacement in the wall. Refer to Photos 21 and 22.

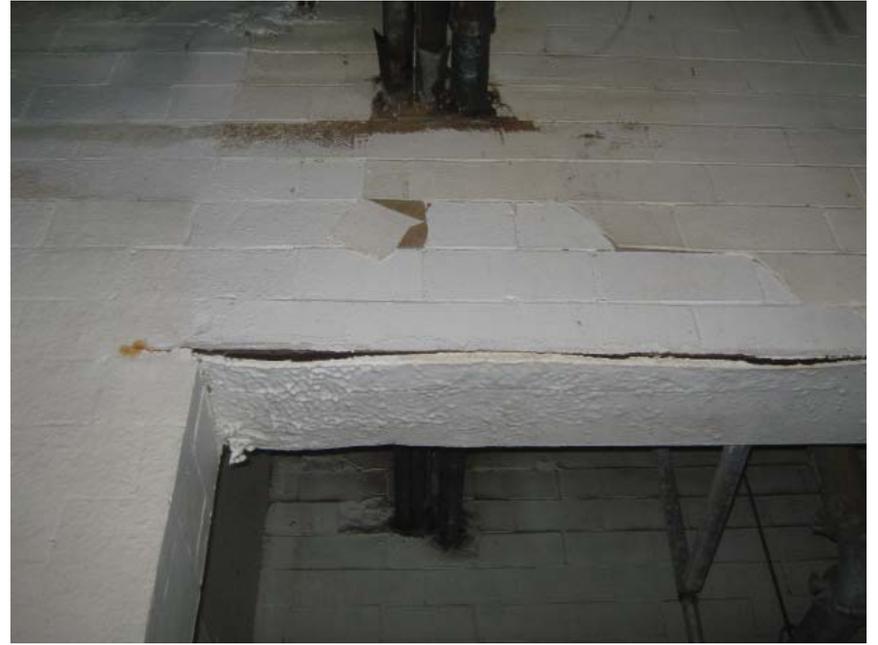
Photo 23

14. One interior wall opening header has been affected by corrosion and is distorted. Refer to Photo 23.
15. One interior wall opening header does not appear to adequate. Refer to Photo 24.
