BERLIN MAYOR AND COUNCIL

Meeting Agenda

Berlin Town Hall 10 William Street Monday, August 28, 2017

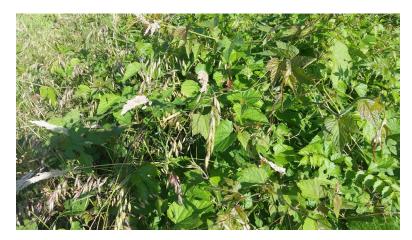
Invasive plants, like these, should be removed and replaced with native ones.

Remove invasive plants and plant native ones. A host of invasive plants including Japanese stiltgrass, Phragmites, Japanese honeysuckle, multiflora rose, Russian olive and privet are dominating sections of the site. Most of this is due to past disturbance and is typical of altered sites. Removal of invasives should wait until a planting plan has been put in place and planting is ready to begin. This can be phased in by area to avoid native plant removal that may result in erosion if soils are exposed. The Natural Resources Conservation Service can make very specific recommendations on what to remove, how to remove it, and what seasonal wildflowers, fruitproducing trees, and wetland plants to plant on all locations on the site. Pond-side invasive wetland plants and the park's westernmost berm will demand the most attention.

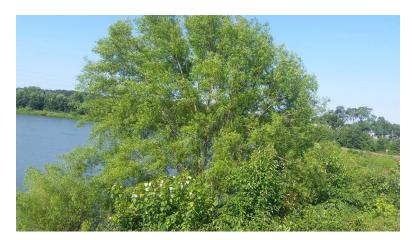
Willow oaks, left undisturbed, can shade and cool the pond, provide wildlife habitat and remove excess nutrients.

Nurture willow oaks. The wildlife friendly native willow oaks on the edge of the ponds should be left to proliferate on their western, northern, and eastern sides. Cutting them is providing sunlight for the highly invasive Japanese stilt grass and warming the water which is helping to produce algae. Cut outs for water access are still appropriate. Pond-side trees will serve the dual function of taking up nutrients and providing shade in the summer months which can improve water quality, limit invasive proliferation, and provide wildlife habitat for herons, turtles, frogs, and a variety of songbirds.

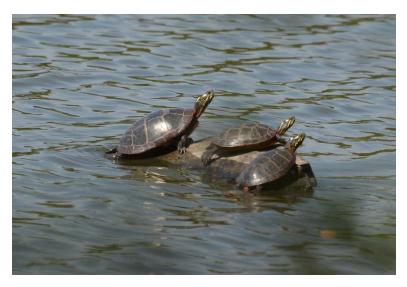
Basking platforms can be installed both to help painted turtles get warm and to give park visitors great looks at them.

Create basking and perching platforms. The park has one of the largest painted turtle populations on the Lower Shore. They are a turtle that loves to bask on logs in open water, but few basking areas exist. The park could easily add a turtle "wow factor" by placing sturdy, non-mobile structures just off the shore to give park visitors a good look at the reptiles and to assist in their survivability. Natural perches can also be installed to attract red-bellied cooters, herons, egrets, cormorants, and other charismatic waterbirds. Infrastructure from the site or fill from other work there could be utilized to create these basking areas.

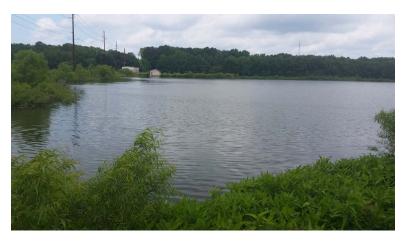
Pond depth is extremely important to dabbling ducks that winter in the pond. If the water is too deep, they will abandon the site.

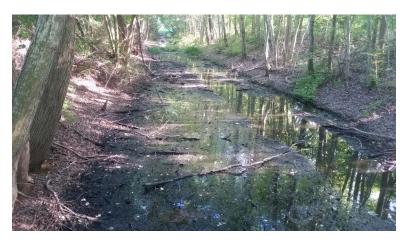
Wetlands behind the ponds and adjacent to the railroad tracks have been altered and degraded over several decades. They can be restored.

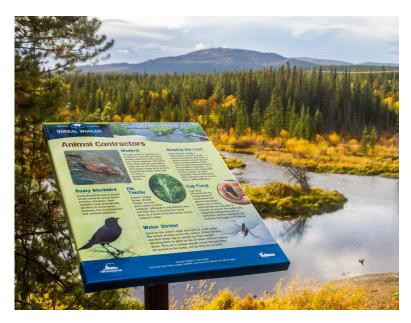
Panels come in a variety of shapes and sizes from wood to plastic to metal with different kinds of mounts.

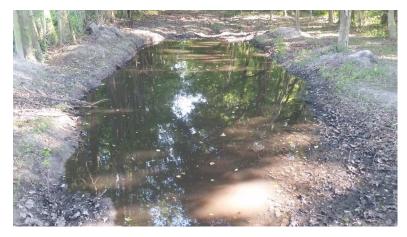
Vehicle use should be prohibited in the woods to avoid scenes like this.

Limit motorized vehicle usage, especially in the woods. The wooded wetlands on the property have been highly degraded from motorized vehicle use. This has caused invasive plant proliferation, hydrology alterations, sediment fluxes to Trappe Creek and Newport Bay, and has created substantial mosquito breeding habitat. The damage in the wet grassy areas directly behind the asphalt area will also encourage mosquito breeding, but is less onerous environmentally than the wetland destruction in the woods. The wetland restoration plan on p.3-4 in this proposal is designed to address these issues by improving water quality and wildlife habitat.

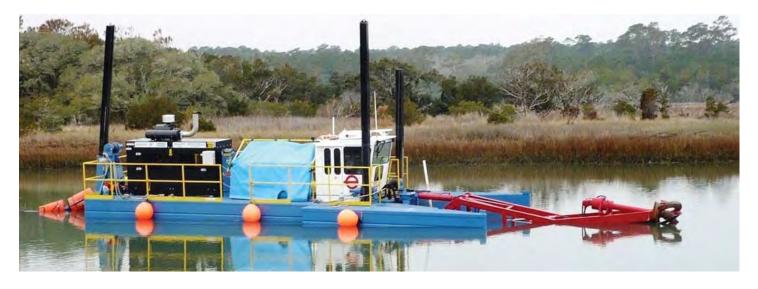
Figure 5-1 Standard Hydraulic Dredge (http://www.dredge.com)

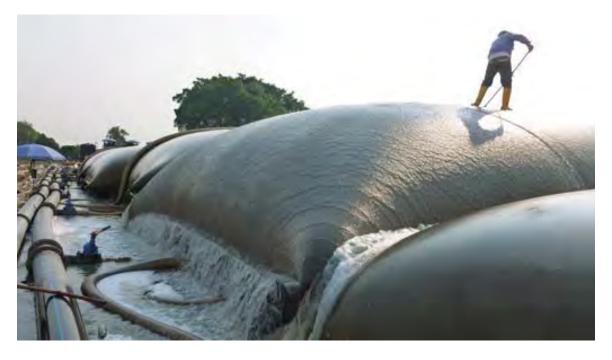
Figure 5-2 Dewatering Using Geotubes (http://www.gowatersolve.com/geotube)

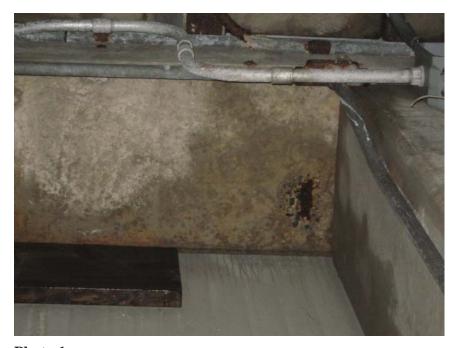
Photo 1

- 1. The roof system is comprised of open web steel roof joists, steel beams, steel columns and steel roof decking. The roof system appears to be in fair to good condition. Refer to Photos 1 & 2.
- 2. Open roof mounted HVAC equipment allows water infiltration into the building. Refer to Photo 3.
- 3. Interior walls appear to be non-load bearing, however interior shear walls will likely be required to remain in service. Masonry walls appear to be in good condition. Refer to Photo 4.

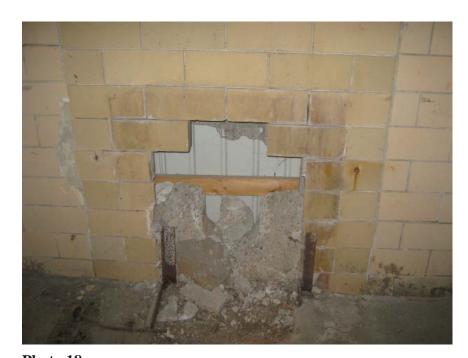
Photo 17

- 12. Openings have been cut in the exterior concrete masonry wall without headers. Refer to Photos 17 through 20.
- 13. Steel headers in the exterior wall have been affected by corrosion, swelled and cause some vertical displacement in the wall. Refer to Photos 21 and 22.

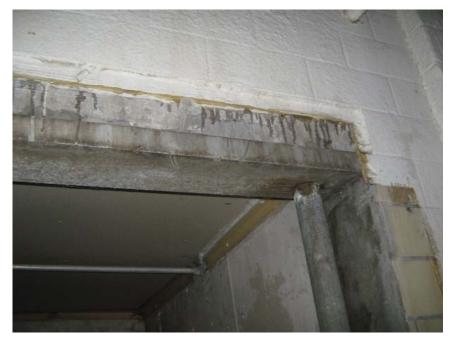
Photo 23

- 14. One interior wall opening header has been affected by corrosion and is distorted. Refer to Photo 23.
- 15. One interior wall opening header does not appear to adequate. Refer to Photo 24.

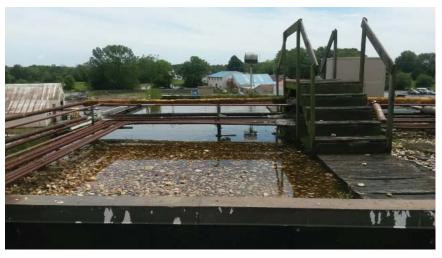
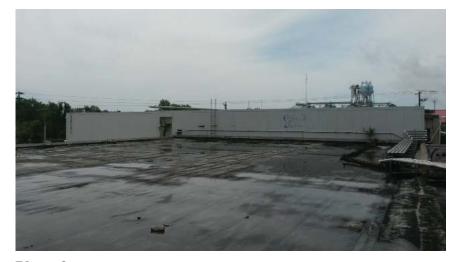
- 1. The condition of the roofing varies significantly throughout the facility. Due to lack of regular maintenance and repair, numerous roof leaks have developed. Insulation is likely saturated with water. The overall condition of the roofing is therefore rated as poor.
- 2. Standing water is common throughout the facility. Refer to Photos 1 through 5.
- 3. Mature vegetation exists in numerous areas. Refer to Photos 6 through 12.
- 4. There are some areas of roofing failure. Refer to Photos 13 & 14.
- 5. Parapet copings and flashing are in poor condition. Refer to Photos 15 & 16.

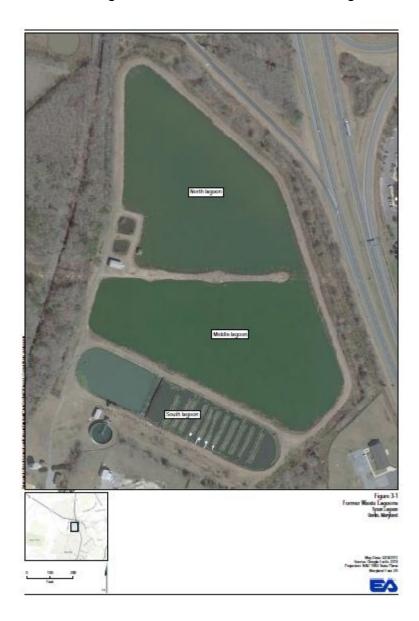
These ponds are shown below (map from EA). Reading from top to bottom of this figure, the slaughter house waste was first discharged into the round holding reservoir shown at the bottom. From there, liquids were pumped into the small pond with plant flotation devices. This pond drained into the larger pond at the top of the figure and eventually runoff was discharged into a natural stream on the right on the ponds.

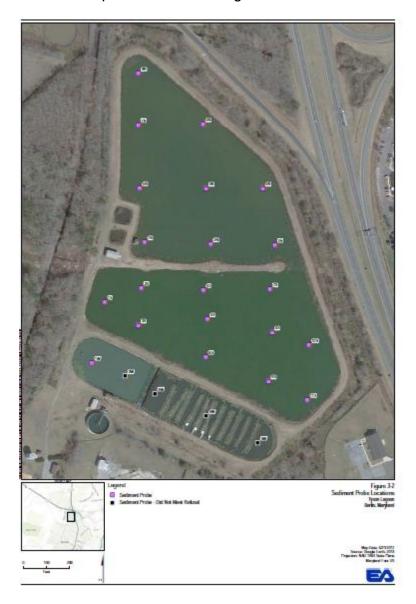
Using information provided by EA and the Town of Berlin, we proposed to take sediment samples at three points within the first discharge pond on the map below. We did not sample from the holding reservoir.
