BUILDING CONDITION ASSESSMENT
BERLIN FALLS PARK
BERLIN, MARYLAND

Prepared For:
The Town of Berlin
10 William Street
Berlin, Maryland 21811

Prepared By:
Davis, Bowen & Friedel, Inc.
601 East Main Street, Suite 100
Salisbury, Maryland 21804

June 16, 2017

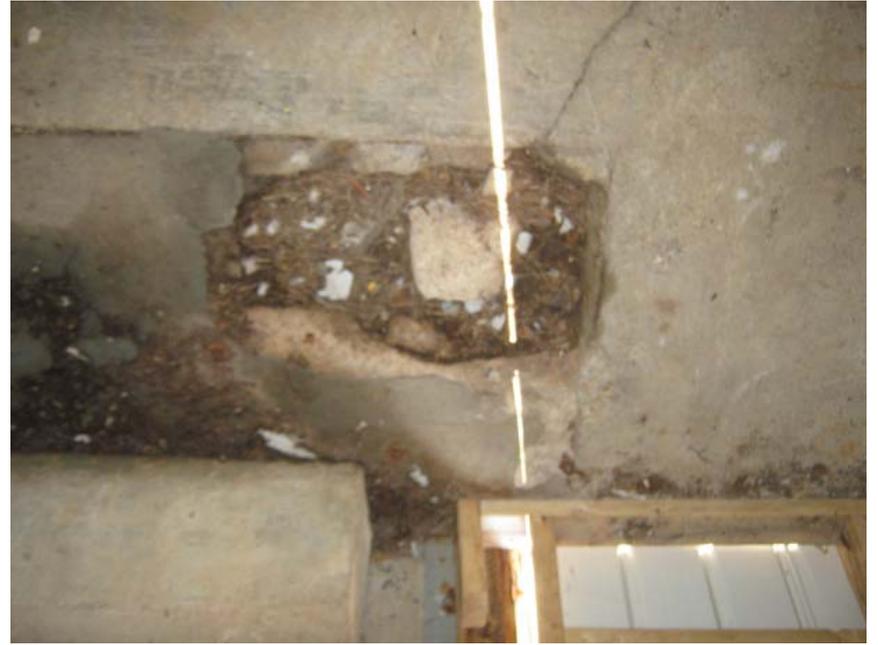
Photo 7

1. The primary structural framing consists of precast prestressed concrete roof tees, beams and columns. The building is enclosed with concrete block masonry curtain walls. Building Area 1 is in fair to good condition.
2. Minor deterioration and corrosion of reinforcing steel in the precast concrete building components were observed. Refer to Photo 1.
3. Open roof mounted HVAC equipment allow water infiltration into the building. Refer to Photo 2.
4. Roof leaks have resulted in staining, minor efflorescence and deterioration of the concrete roof framing. Refer to Photos 3 through 6.
5. Large spalls exist in the concrete floor slab. Overall the floor slab is in fair condition. Refer to Photo 7.
6. There are floor drains in the concrete slab. Refer to Photo 8.

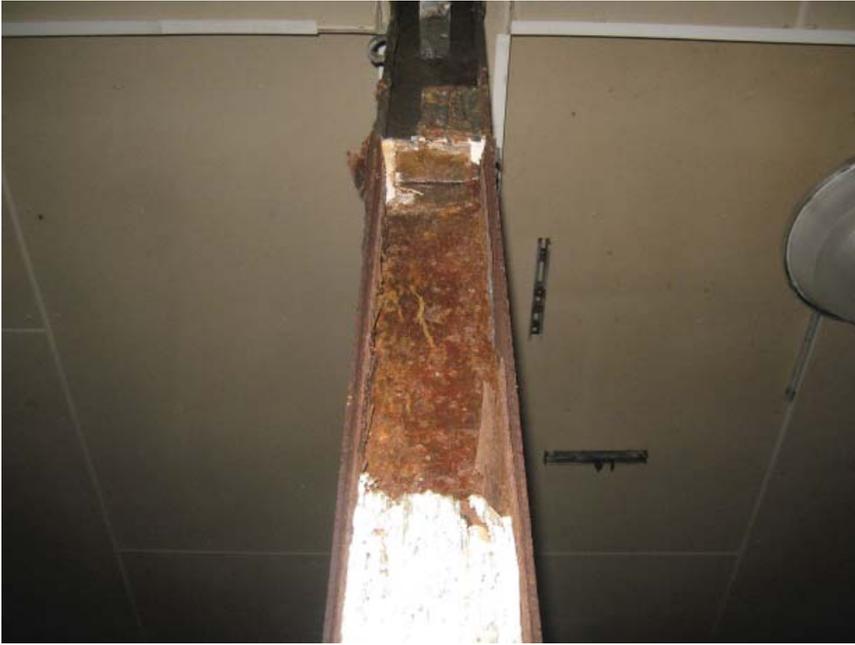
Photo 5

4. Roof leaks have resulted in staining, minor efflorescence and deterioration of the precast concrete roof framing. Refer to Photo 5.
5. Exterior concrete masonry walls are in poor condition. Foundation settlement is apparent. Headers are not properly supported. At least one exterior pilaster is disconnected and displaced from the exterior wall. Refer to Photos 6 through 8.

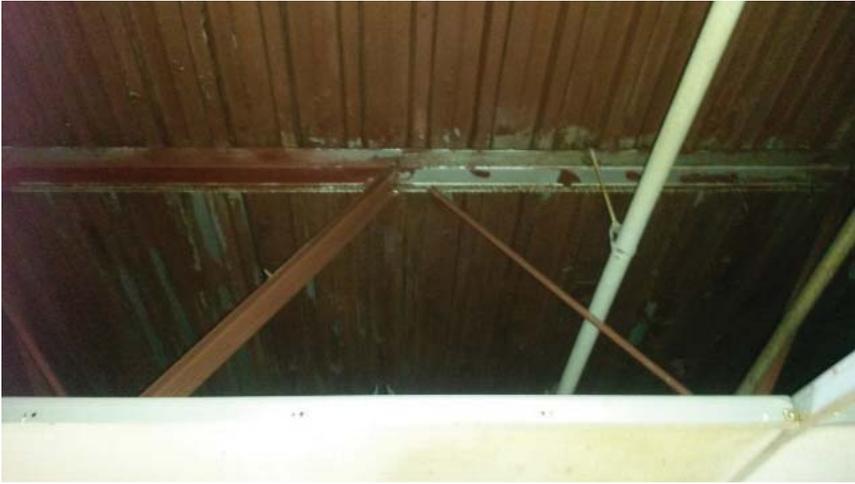
Photo 9

6. There is significant deterioration of the concrete floor slab and trench drains. Refer to Photos 9 & 10.

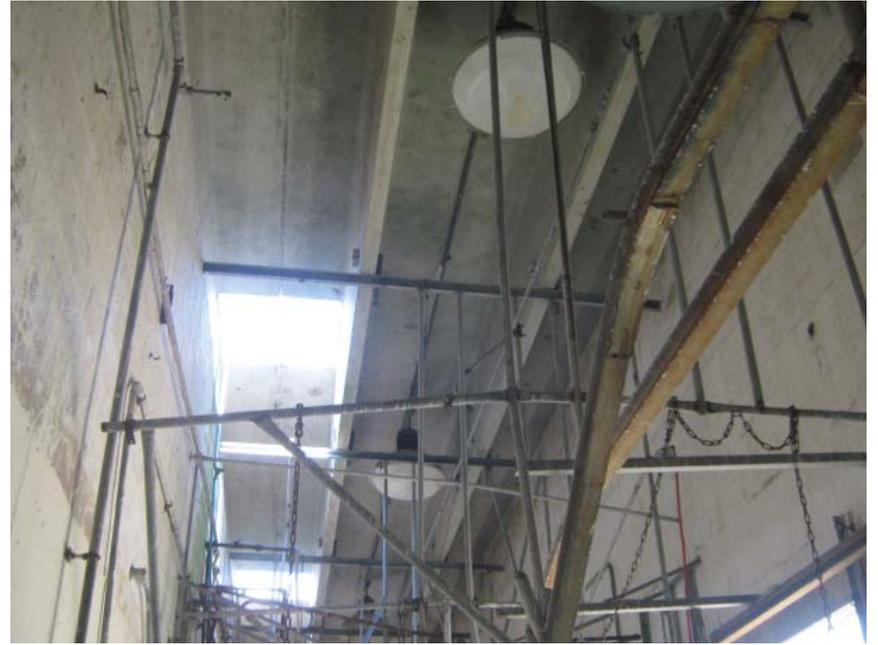
Photo 3

2. Exterior walls are concrete block masonry with some interior glazed block. Refer to Photo 3.
3. Roof drains are leaking. Refer to Photo 4.
4. The roof decking is in fair to poor condition with some areas of significant deterioration especially around roof drains. Refer to Photos 5 and 6.

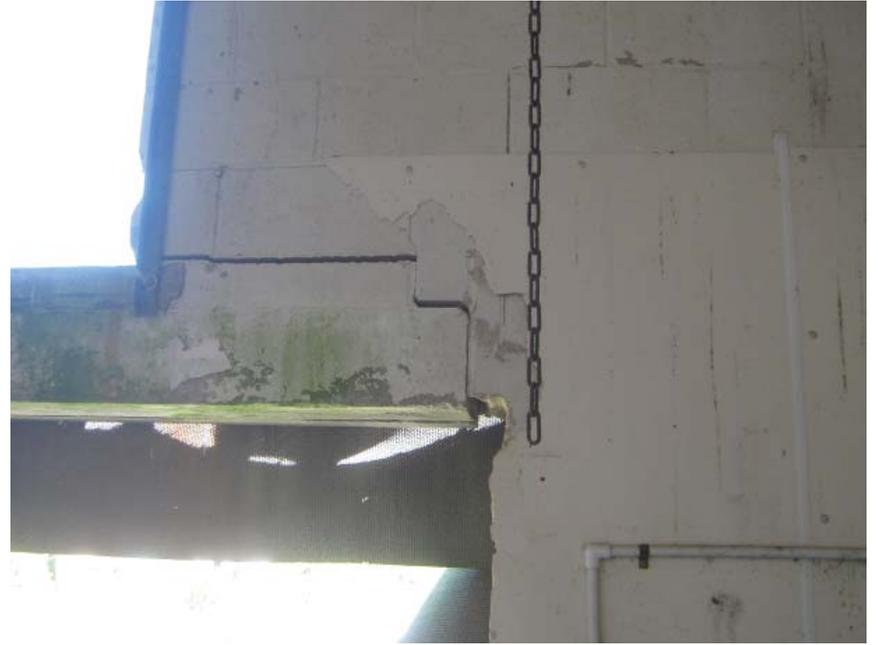
Photo 7

5. The open web steel joists are short span and therefore light duty. Member thicknesses are as little as 1/8 inch. Corrosion has caused a significant reduction in member capacity. Refer to Photos 7 and 8.

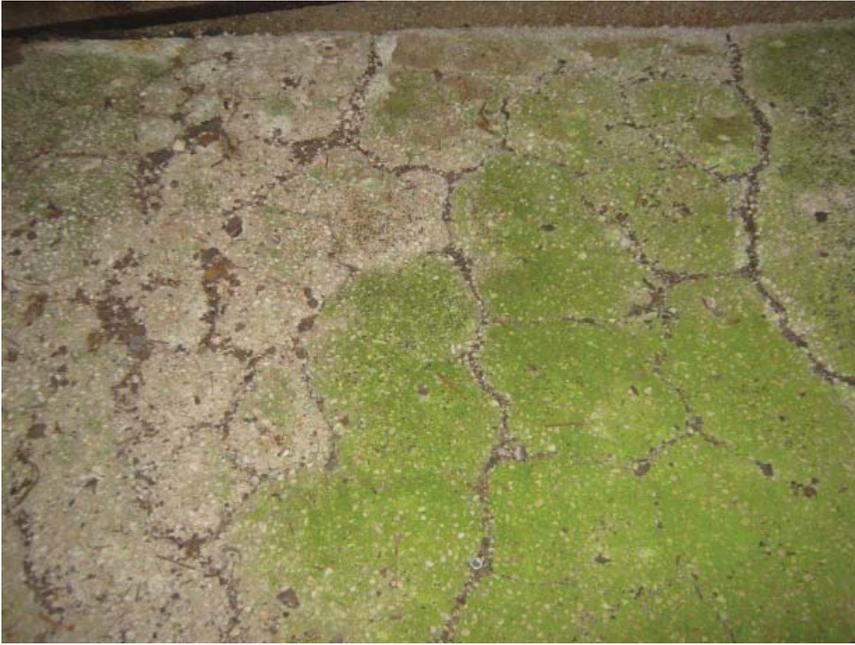
Photo 9

6. Some open web joist diagonals have been damaged. Refer to Photo 9.
7. The bottom chord of at least one joist broken. Refer to Photo 10.
8. The bottom chords of many joists have been altered by drilling and welding. Refer to Photo 11.

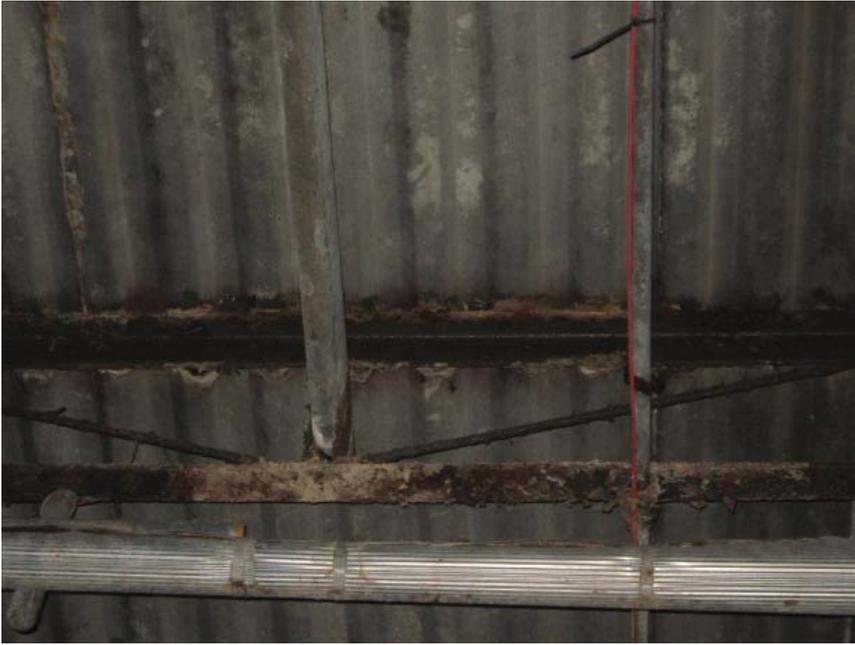
Photo 1

1. Area 6 former use was Boiler Room and Mechanical Shop.
2. The roof system is comprised of steel roof decking, open web steel roof joists, steel beams and steel columns.
3. Exterior walls are concrete block masonry.
4. The steel roof deck over the old Mechanical Shop is in poor condition. Refer to Photos 1 & 2.
5. The open web steel joists supporting the roof of the old Mechanical Shop are in fair condition. Refer to Photo 3.
6. The roof decking and steel joists over the old Boiler Room are in a severely deteriorated condition. Refer to Photo 4.

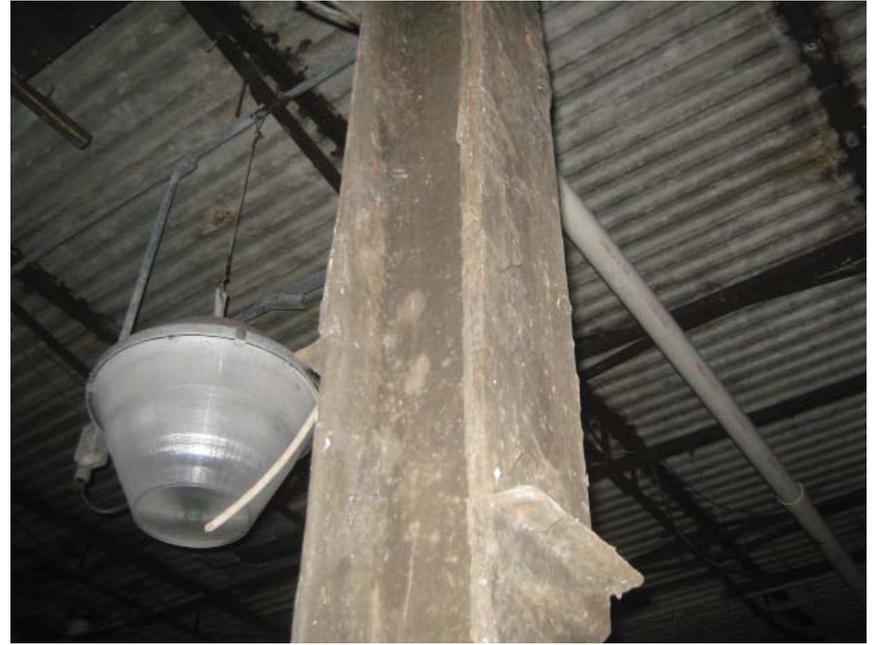
Photo 15

9. The joists are therefore in generally poor to failed condition.
10. Holes have been cut into the webs of some steel beams. Refer to Photo 12.
11. The steel columns are in fair to poor condition. Portions of the columns exhibit significant corrosion, severe pitting, impact damage and delamination. Refer to Photos 13 through 16.

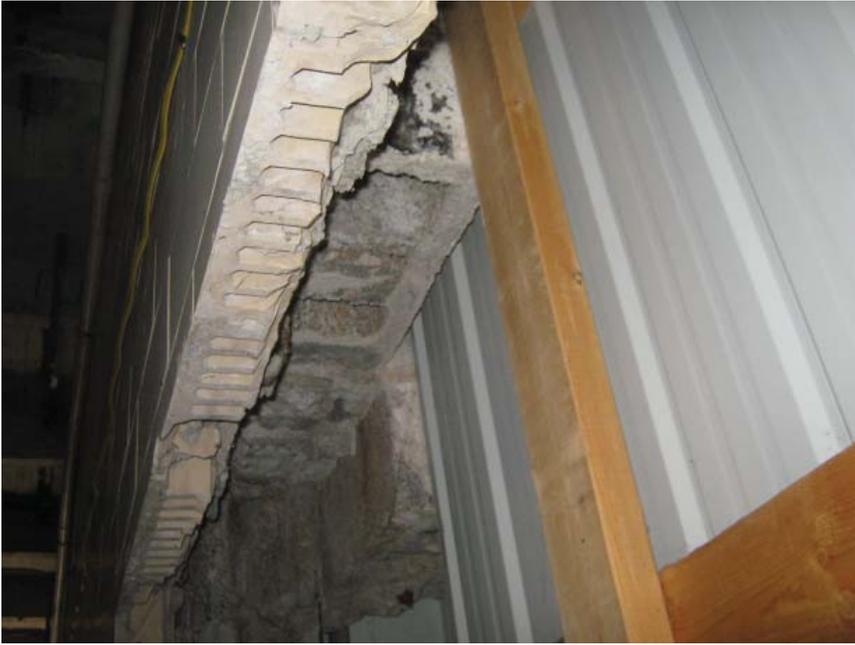
Photo 17

12. Openings have been cut in the exterior concrete masonry wall without headers. Refer to Photos 17 through 20.
13. Steel headers in the exterior wall have been affected by corrosion, swelled and cause some vertical displacement in the wall. Refer to Photos 21 and 22.

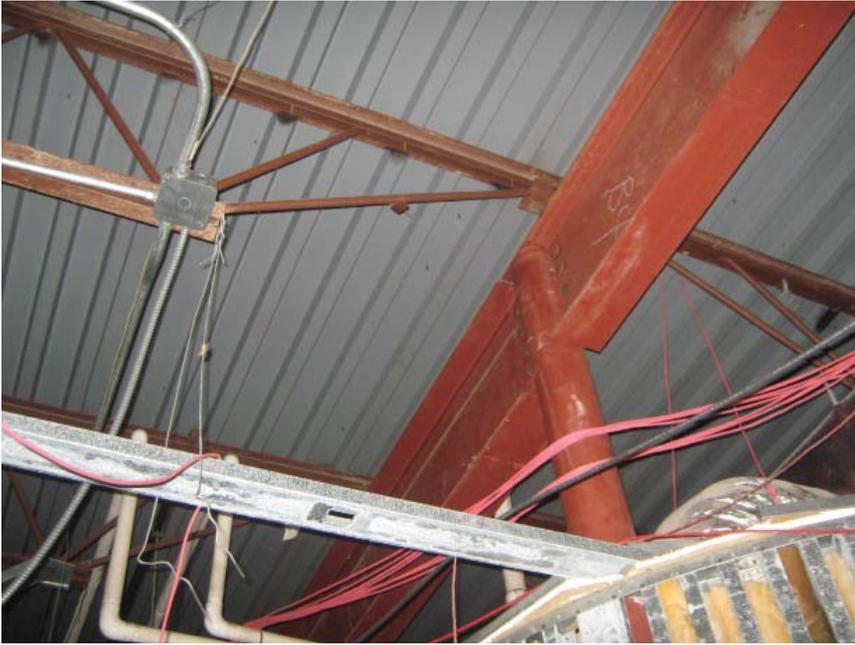
Photo 1

1. The roof system is comprised of open web steel roof joists, steel beams, steel columns and steel roof decking. The roof system appears to be in fair to good condition. Refer to Photos 1 & 2.
2. Open roof mounted HVAC equipment allows water infiltration into the building. Refer to Photo 3.
3. Interior walls appear to be non-load bearing, however interior shear walls will likely be required to remain in service. Masonry walls appear to be in good condition. Refer to Photo 4.
