**PHASE II LIMITED ENVIRONMENTAL SITE ASSESMENT  
FORMER TYSON FOODS PROCESSING PLANT  
9943 Old Ocean City Boulevard  
BERLIN, MARYLAND 21811**

Froehling & Robertson, Inc.  
7798 Waterloo Road  
Jessup, Maryland 20794  
443-733-1011

F&R Project Number F68-035E  
December 17, 2004

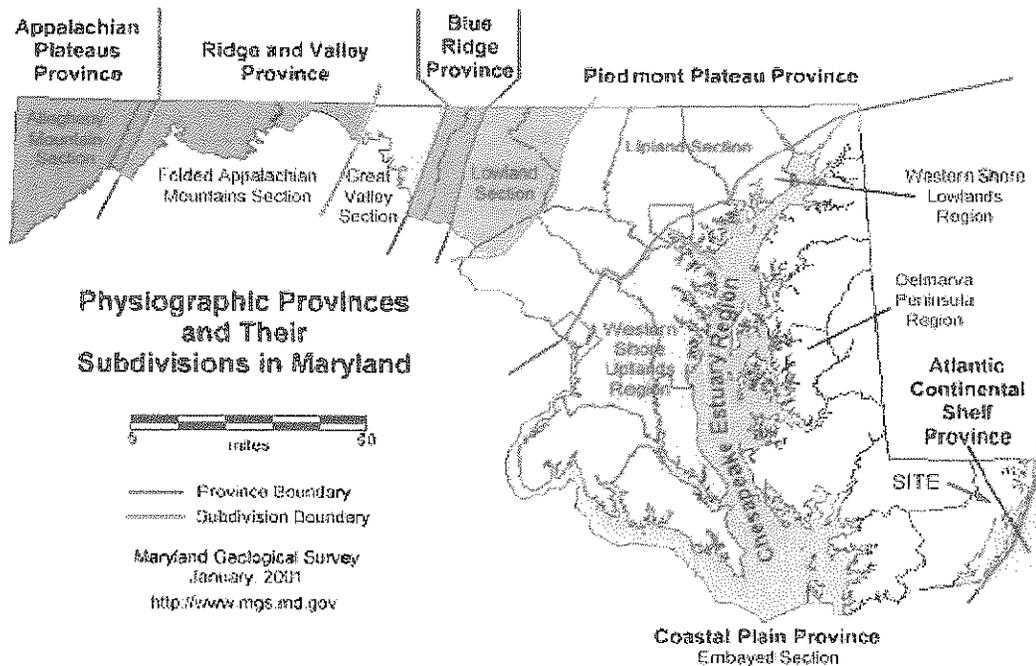
Diagram A - Physiographic Provinces

The project site and the surrounding area are located within the Coastal Plain Physiographic Province. The Coastal Plain Physiographic Province is underlain by unconsolidated sediments including gravel, sand, silt, and clay. This wedge of sediments thickens towards the east and reaches depths of more than 8,000 feet at the Atlantic coastline. The sediments of the Coastal Plain are inclined slightly eastward, and range in age from Triassic to Quaternary. Groundwater within the Coastal Plain is characterized by sand and gravel aquifers interlayered with silt and clay confining units. Diagram A – Physiographic Provinces shows the site's location in relation to the Physiographic Provinces of Maryland.

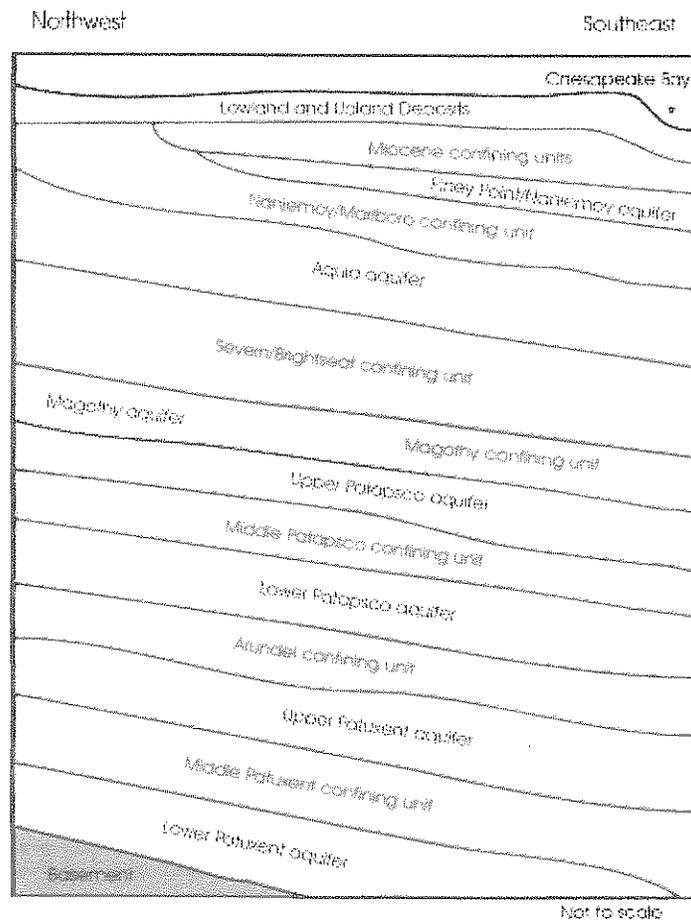
### Diagram B – Maryland Coastal Plain Aquifer Cross Section

Please refer to Diagram B – Aquifer Cross Section, which graphically illustrates the general subsurface conditions prevalent in coastal area similar to those encountered at the Tyson site.

Aquifers located beneath a confining layer may be under pressure relative to the surface and will flow naturally from a well when accessed. Unconfined aquifers are more common and do not have a low-permeability deposit above them. Water in unconfined aquifers may have arrived recently by percolating through the land surface. Water in unconfined aquifers is often considered very young, in geologic time. The top layer of an unconfined aquifer is the water table. It's affected by atmospheric pressure and changing hydrologic conditions, including local rainfall events. Discharge and recharge rates in unconfined aquifers depend on the hydrologic conditions above them. Unconfined aquifers located within Coastal Plain geology are particularly susceptible to ground surface releases of contaminants due to the

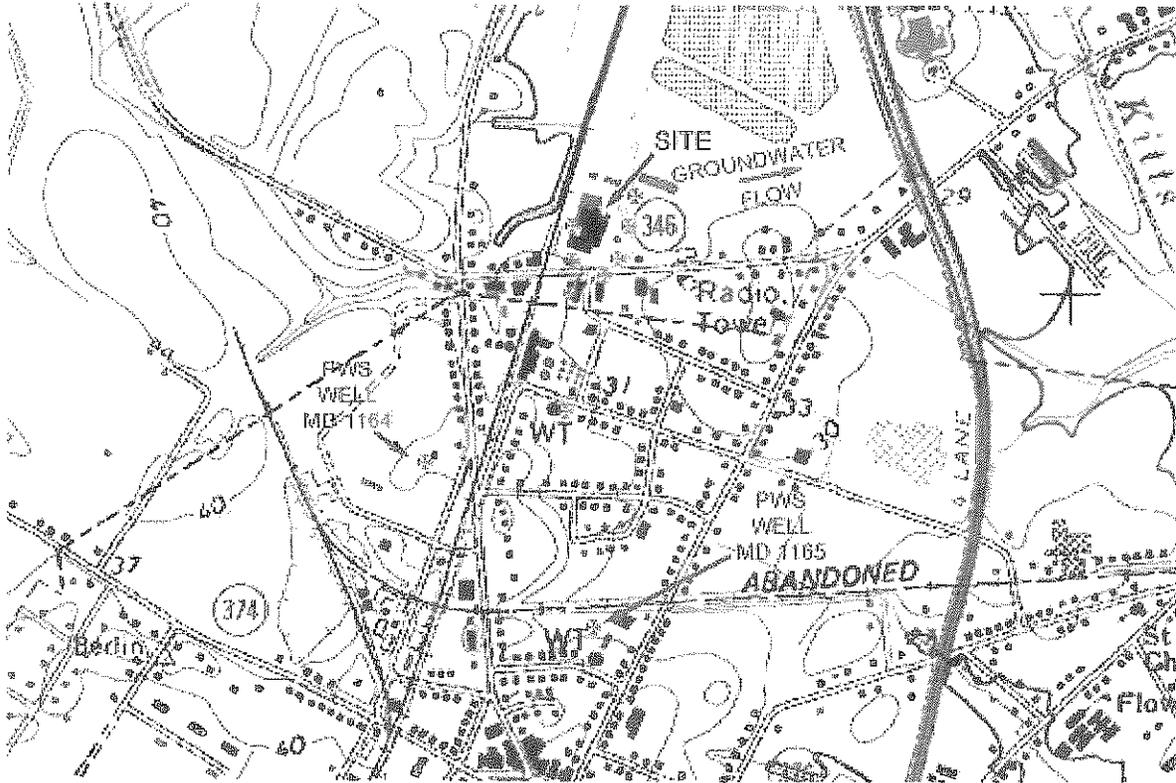
Diagram C – Berlin Well Location Map

\* WELL LOCATION

F&R accessed Open File Report No. 2001-02-14, *Estimation of areas contributing recharge to selected public supply wells in designated metro core areas of Upper Wicomico River and Rockwalking Creek basins, Maryland* on the World Wide Web at <http://www.mgs.md.gov/hydro/rockindex.html> to qualify the extent to which water supply wells might impact groundwater movement in a aquifer similar to the site's. The aquifer used for the cited report is also an unconfined, shallow water table aquifer located within the Coastal Plain Physiographic Province of Maryland. The report found that within this aquifer 50-year contributing areas related to two supply wells pumping at 0.36 million gallons per day formed an elongated depression pattern on the water table that extended approximately 4 miles from the wells.
